# HANDY GUIDE

European experiences in  
rehabilitation: Six case studies

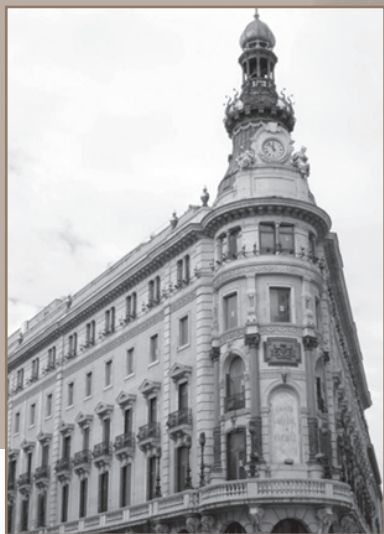
Before the renovation

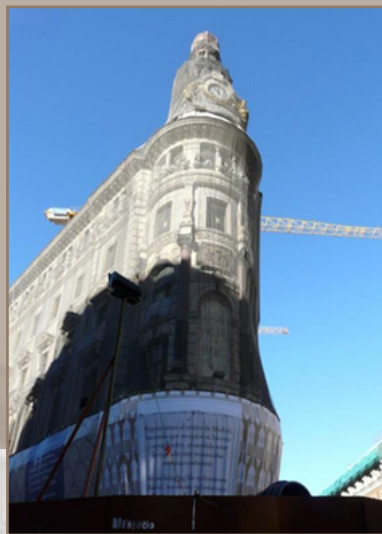
During the renovation

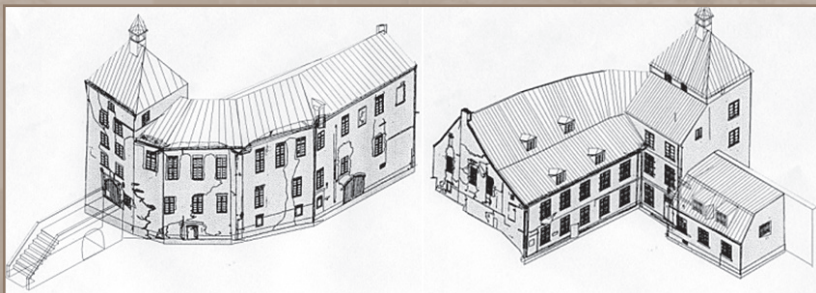
Before the renovation (left: North-West, right: South-East)

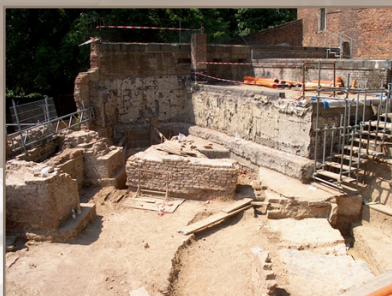
During the renovation  
(in front of the southern façade)

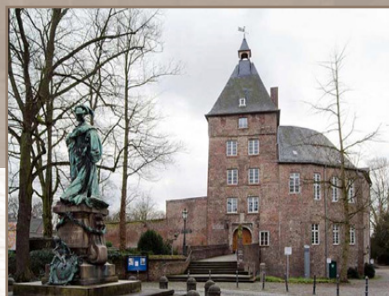
Entrance tower and Western facade  
(ivy already removed)

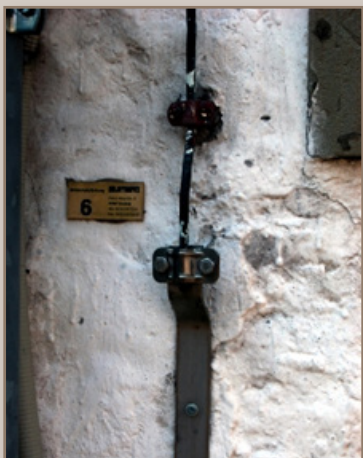
New lime plaster with repaired  
thunderbolt protection

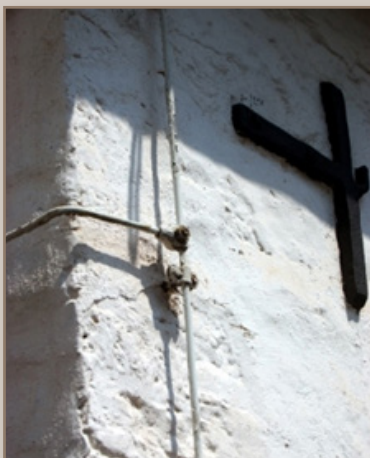
Renewing the joints  
(pausing colleagues)

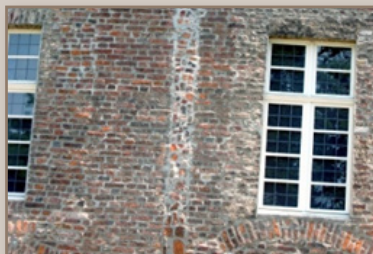
Repaired crack in the facade

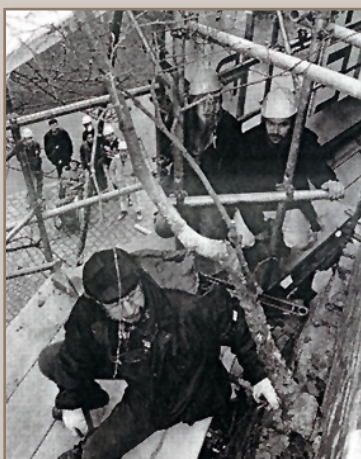
Removing the birch in the masonry

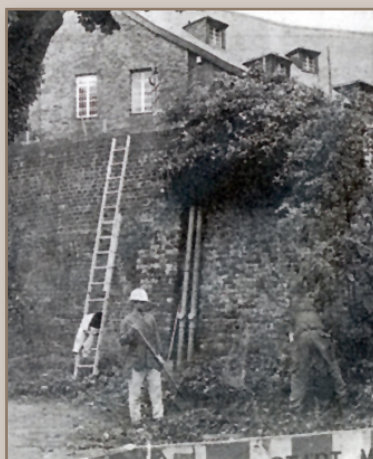
Removing plants in the masonry

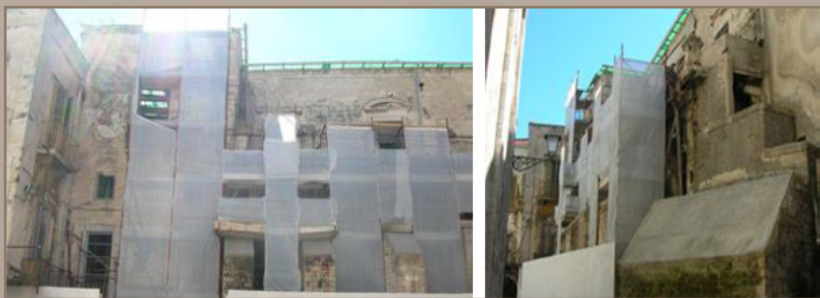
The building, before the restoration works , appeared in a state of complete abandonment. The phenomena of deterioration concerned every element of the structure, bearing walls in a poor state of preservation at elevated structures with obvious large crack patterns and release phenomena of material ejection. Such structures, after a continuous exposure to meteoric phenomena , given the absence in certain spaces of coverages , cause collapse, they had been subjected to soaking, with consequent impoverishment of the masonry core. The old wooden floors were deteriorated, partially or totally collapsed.

Before the renovation

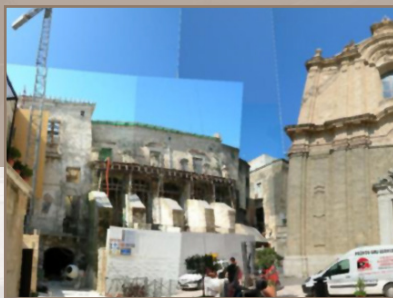
During the renovation

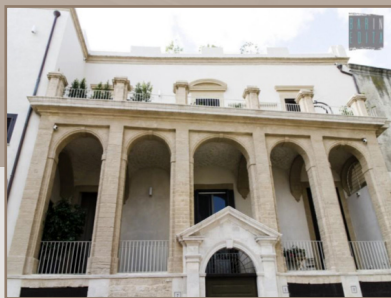
After the renovation

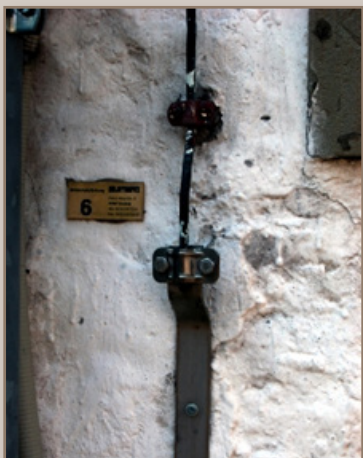
New lime plaster with repaired  
thunderbolt protection

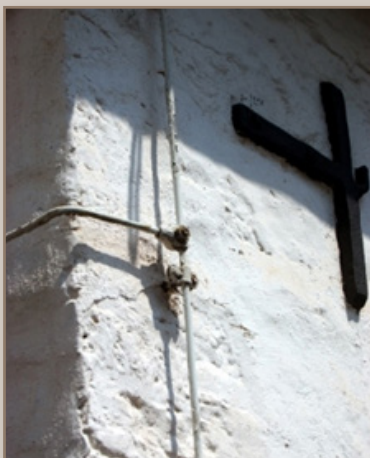
Renewing the joints  
(pausing colleagues)

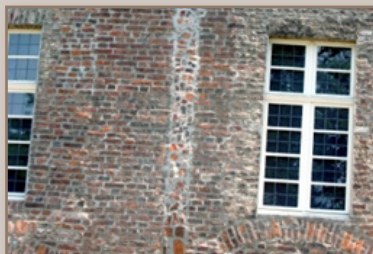
Repaired crack in the facade

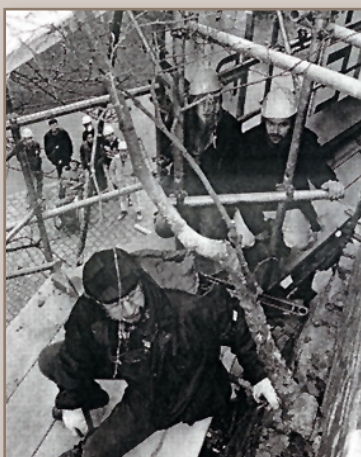
Removing the birch in the masonry

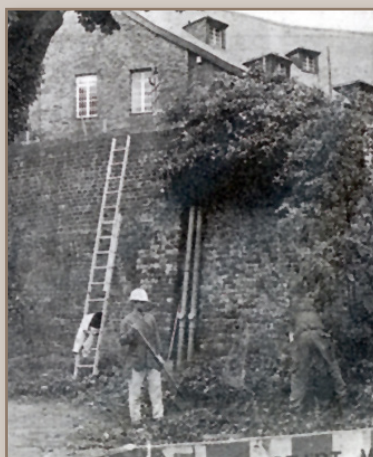
Removing plants in the masonry

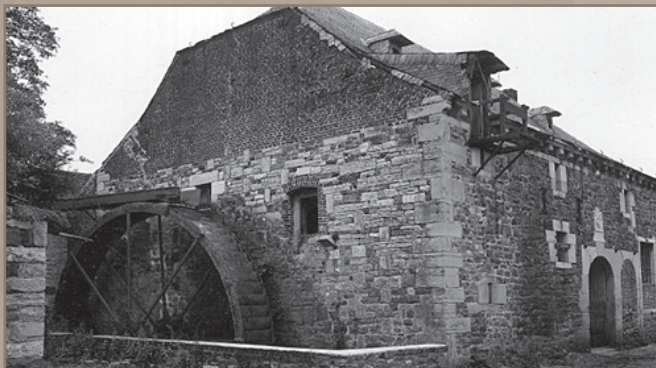
The building was abandoned in the years 1950 and get gradually deteriorated (infiltrations of water in the roof and then in the masonry) and was in the state of ruin in the early 2000s.

Before the renovation

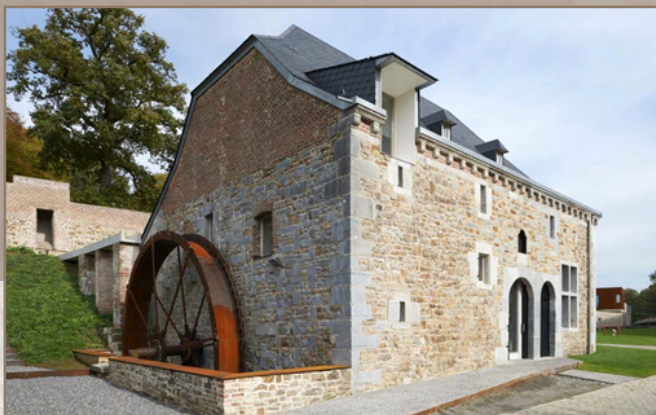
After the renovation

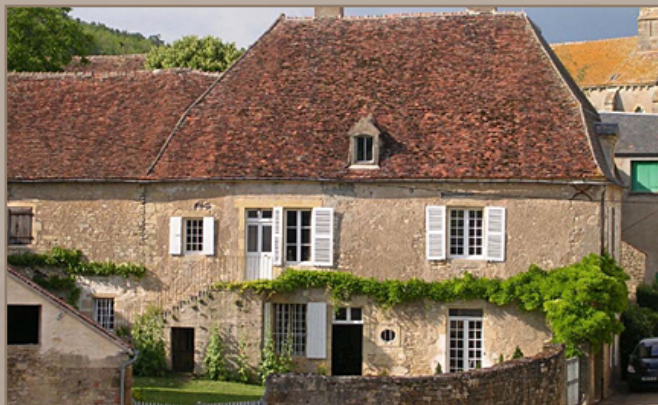
Before the renovation

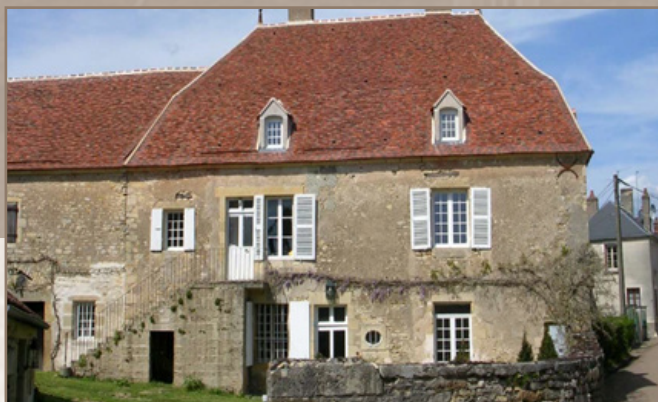
After the renovation

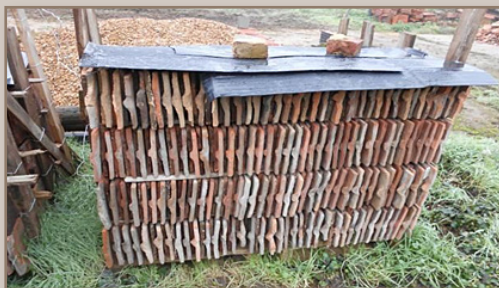
Removal and storage of the ridge tile and removal of the damaged battens and chevrons

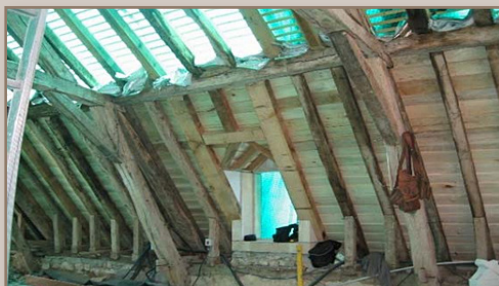
Consolidation of the frame elements

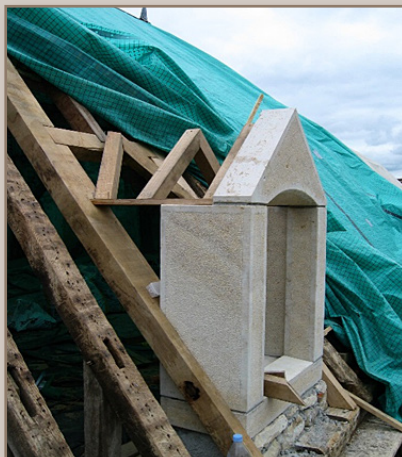
Copy of the existing skylight and matching of the frame elements to fit the skylight

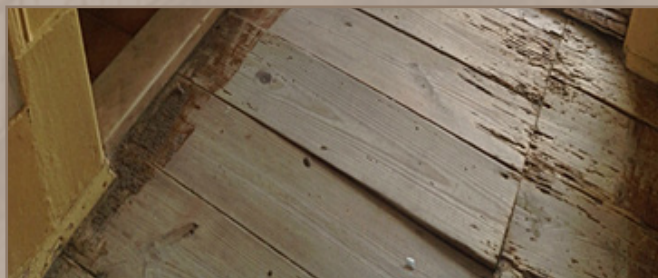
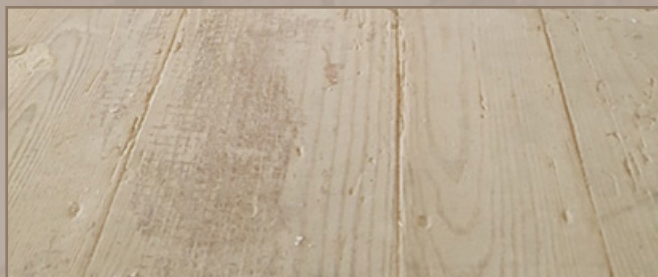
Before the renovation

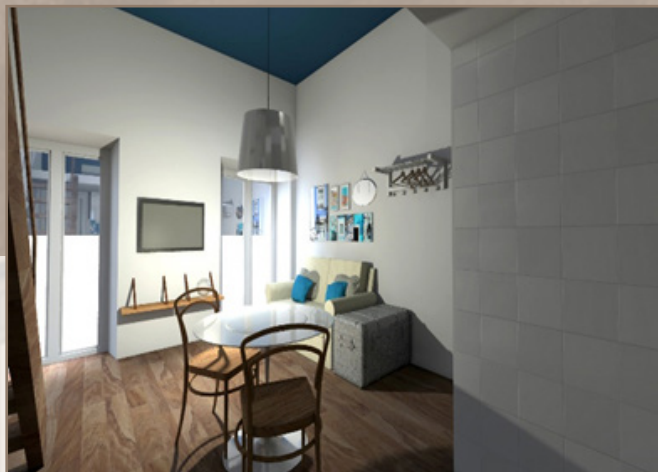
After the renovation

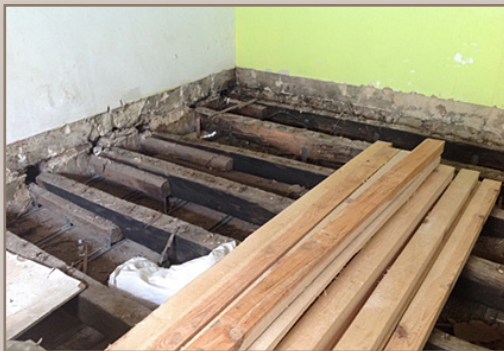
**Step 2** Splices of the old beams deteriorated to strengthen the structure

Splices (Empalme): fixing of new pieces of wood to antique pieces.
