# HANDY GUIDE

European experiences in  
rehabilitation: Six case studies

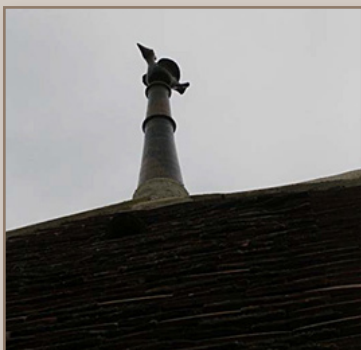
Realization of copper valleys and hips

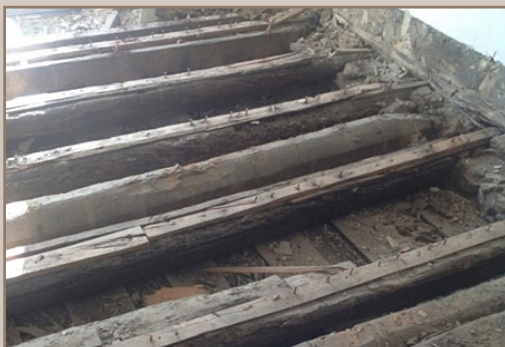
Step 3 Check the necessity of floor levelling

Step 2 Check the possibility of removal of the materials in bad condition (May be required to support the ceiling the lower floor)
